PASSAIC RIVER BASIN

# CRYSTAL LAKE DAM

PHASE I INSPECTION REPORT

NATIONAL DAM SAFETY PROGRAM

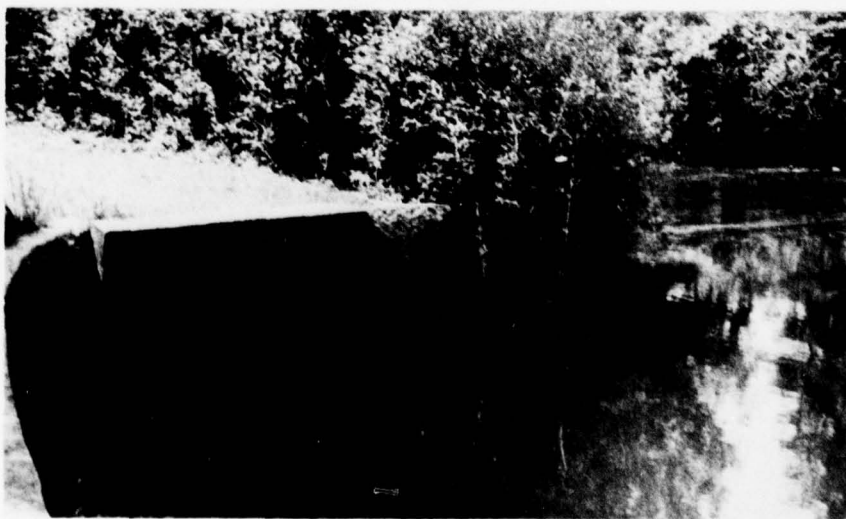
UPSTREAM LEFT ABUTMENT  
NOTICE TILTED HEAD WALL

(2) The cracked and tilted left hardwall at the 36-inch pipe drain should be repaired before its failure obstructs or damages the outlet gate.

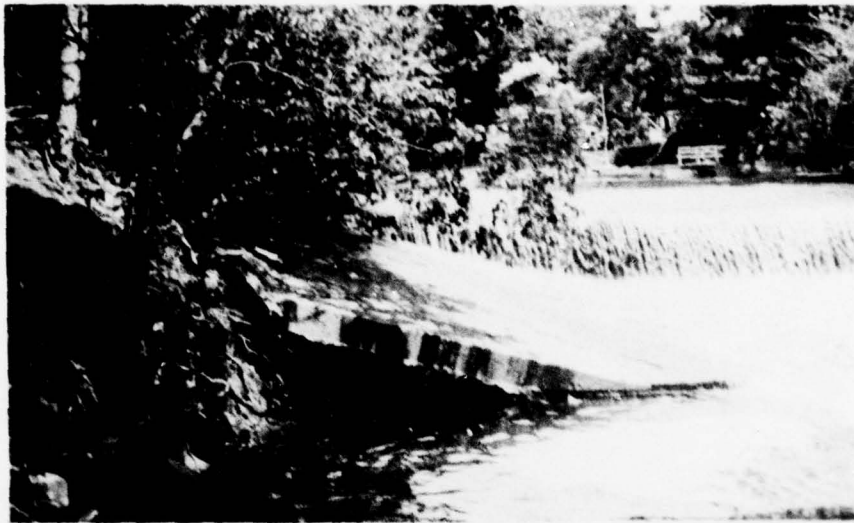
VISUAL EXAMINATION OF	OBSERVATIONS	REMARKS OR RECOMMENDATIONS
STRUCTURAL CRACKING	<p>The left wing wall, at the intake side, has a 45° crack running from top of wall to top of 36-inch outlet pipe. The top of this concrete wall is badly deteriorated and the wall is tilted towards lake. The left wall has two vertical cracks, 3 feet apart, 12 feet from downstream edge of wall.</p>	
VERTICAL AND HORIZONTAL ALIGNMENT	Fairly good.	
MONOLITH JOINTS	None visible.	
CONSTRUCTION JOINTS	<p>At the right downstream corner of the wall and the slab a 4-inch gap was found. A 2-inch gap exists between the slab and downstream drop apron; a 4-inch void was found below the right downstream wall and slab.</p>

DOWNSTREAM DROP SPILLWAY APRON  
RIGHT ABUTMENT

(1) The extensive undermining of the right drop apron foundation should be corrected by suitable methods such as grouting.
